Transshipment observers – a tool for understanding seabird bycatch mitigation measures use on high seas tuna longline vessels

Philip H Augustyn^{1,2} and Ross M Wanless^{2,3}

Abstract

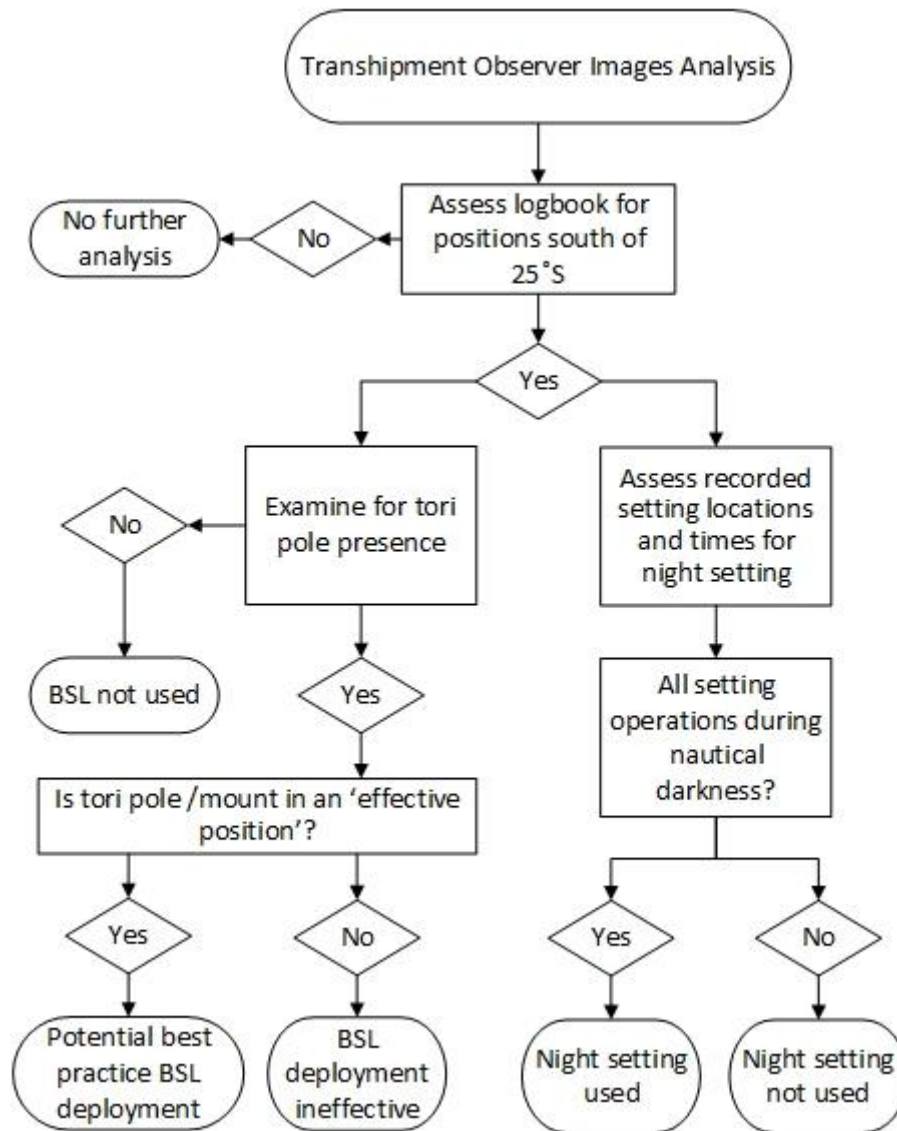
Figure 1. Process flow for analysing IOTC transshipment observers' photographs for tuna longline vessels use of bird scaring lines and night setting.

Transshipment photographs were received in batches for each transshipment voyage. The process of relating images to vessel identification, tori pole presence/placement/nature and logbook information (for night setting south of 25°S) is shown in Fig 1. Photographs of logbook entries were not comprehensive, and generally included positions of the last few days fished before the vessel transhipped, but occasionally included up to seven weeks' fishing history. If fishing had not been recorded south of 25°S, images were discarded. If the vessel had fished south of 25°S, images were analysed further according to the schedule in Table 1.

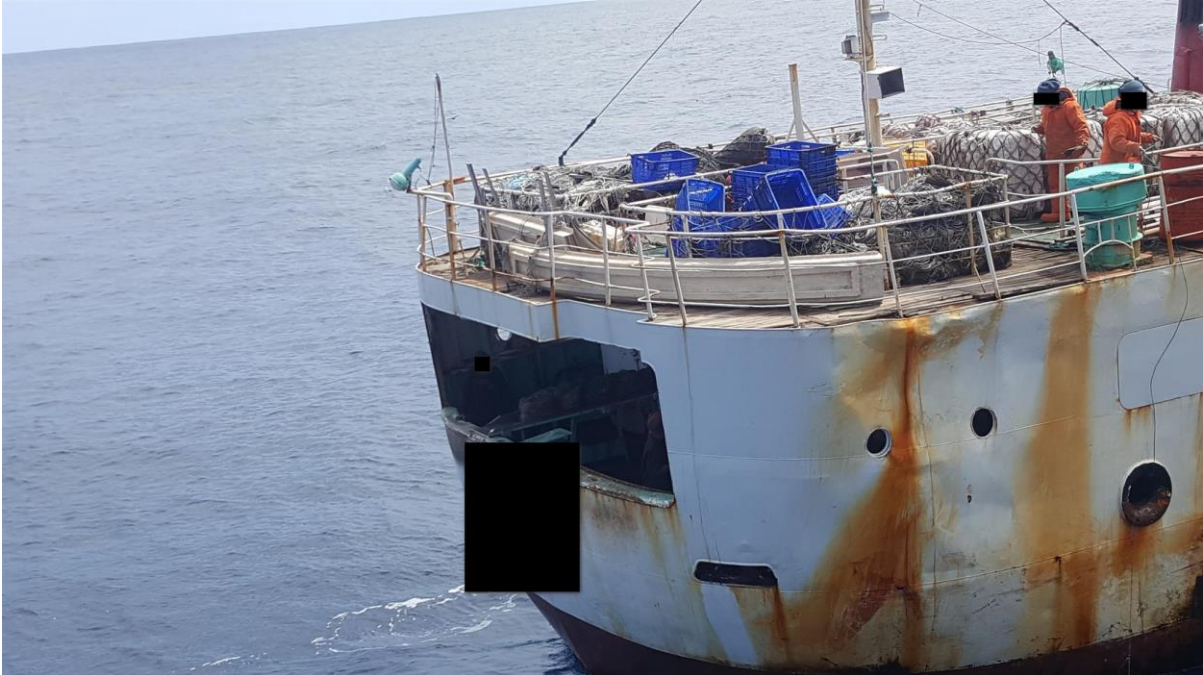
Figure 2. Image from a transshipment observer of a tuna longliner >35 m length, showing a tori pole that was assessed in this study as being below 7 m above the waterline, and therefore an ineffective position.

A tori pole was identifiable as a sturdy pole, at or near the stern of the vessel, raised above the height of the deck with the potential of attaching a BSL (Figs 2-3 and Annex). We defined an 'effective position' as a pole that could hold a BSL and achieve the performance specifications according to Res 12/06, i.e. 100 m and 75 m aerial extent for vessels with LOA of >35 m and ≤35 m, respectively. Effective position was evaluated against the following criteria:

1. Height: top of pole is estimated to be at ≥7 m or ≥6 m above the waterline for vessels of >35 m and ≤35 m total length, respectively
2. Structurally sound: pole appearing to be of sufficient strength to support the towing of a BSL (including apparently solid construction and/or supported by back stays or other strengthening systems)

For this analysis, determination of effective positions required judgement of an experienced scientific observer (PHA) and estimates of various aspects. The BSL attachment point height above the waterline was estimated by comparing known vessel top-deck heights (PHA pers obs). Smaller vessels (<35 m) generally have fibreglass hulls and a railing height of ~4.5 m whereas larger, steel-

hulled vessels of approximately 50 m typically have railings 5–5.5 m above the waterline. Whenever possible, other reference points in images, such as people and objects (e.g. fishing buoys) were also used to estimate tori pole height.

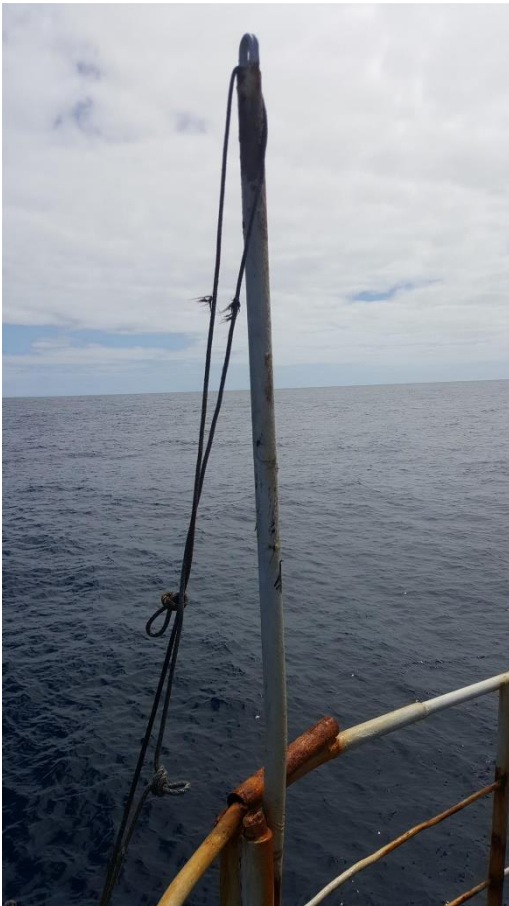
Figure 3. Image from a transshipment observer of a tuna longliner showing a tori pole that was not considered structurally sound. It lacks back stays or other strengthening systems

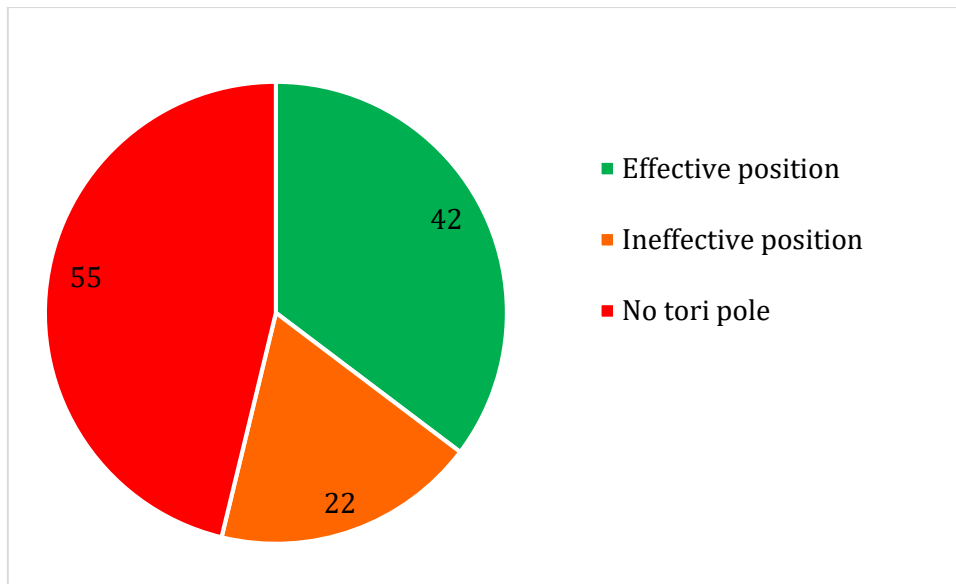
Figure 4. Proportions of presence and likely effectiveness of tori poles for bird scaring line attachments on tuna longliners in the Indian Ocean, assessed using transshipment observers' photographs.

Of the 119 vessels for which photographs allowed us to evaluate tori poles, 54% had a tori pole present, and of those that had a pole, two thirds were likely to support an effective BSL (Table 2). This means that overall only 36% of vessels (42 of 119) were considered likely to be able to deploy an effective BSL that follows Best Practice design and performance specifications (Fig 4). There were also clear differences in likely effectiveness of BSL usage amongst the fishing entities in this study. Of those for which we had >5 vessels to analyse, two (D and E) had very high proportions of vessels with effective tori pole positions, whereas entities B and F had a comparatively low numbers of vessels with effective tori poles.

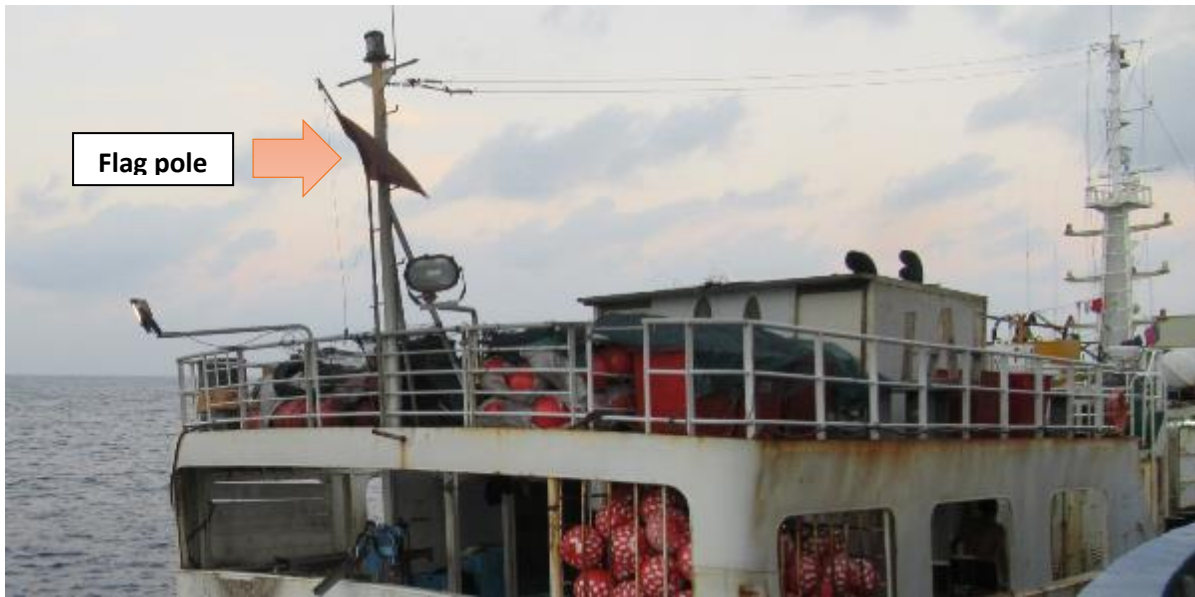
Figure A3. Note the flag pole, which is not a tori pole or BSL attachment point.

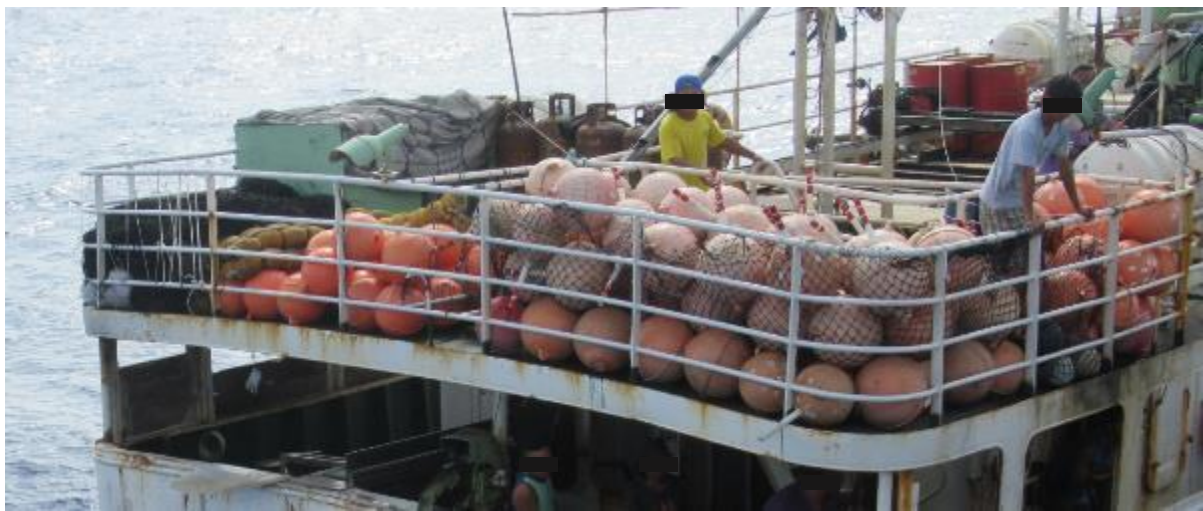
Figure A4. No tori pole visible anywhere on the top deck.

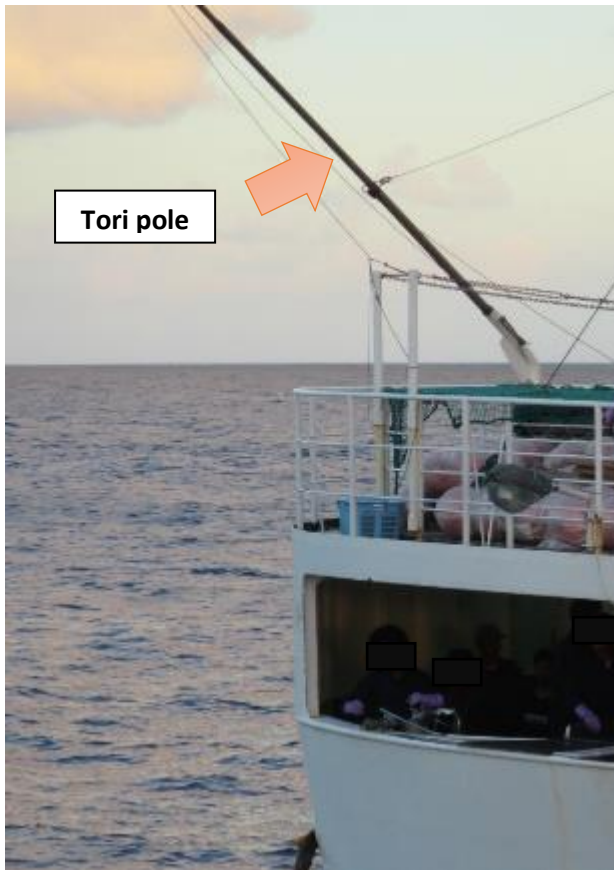
Figure A5. A good example of a torii pole mounted over the bait casting area. Even though the photo only includes part of the TP, it is clearly higher than 7m above the waterline and would qualify as a best practice (BP) installation.

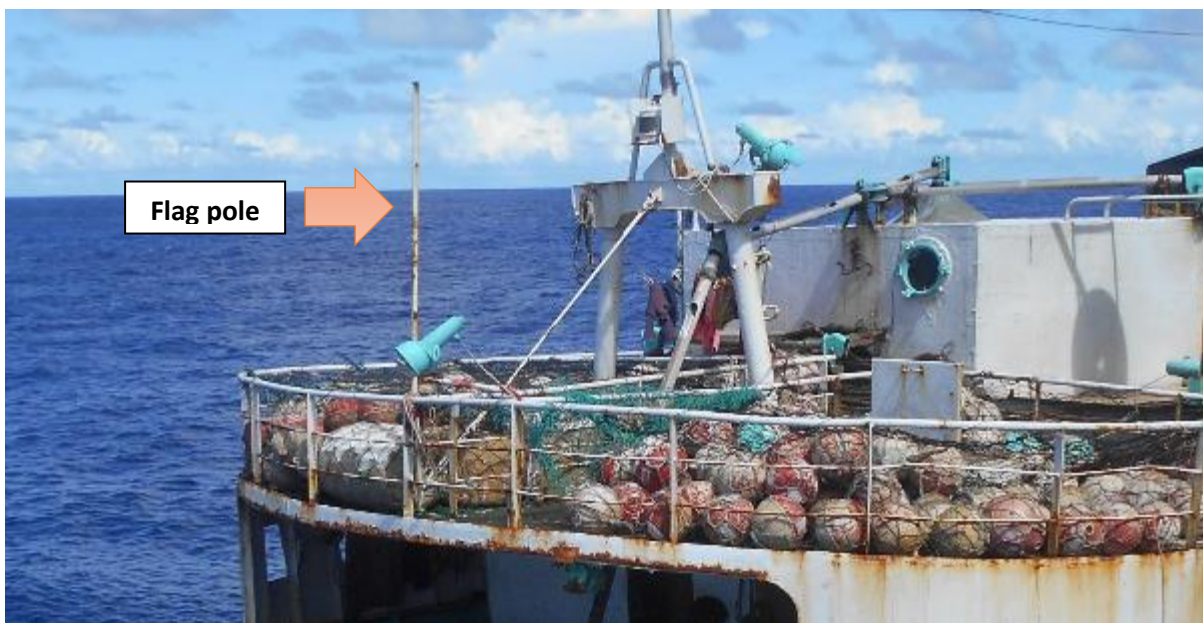
Figure A7. Flag pole attachment point. These are not torii poles and would not be able to withstand the drag of a BSL. During PBO visits, some captains have tried to sell this as a BSL mounting position.

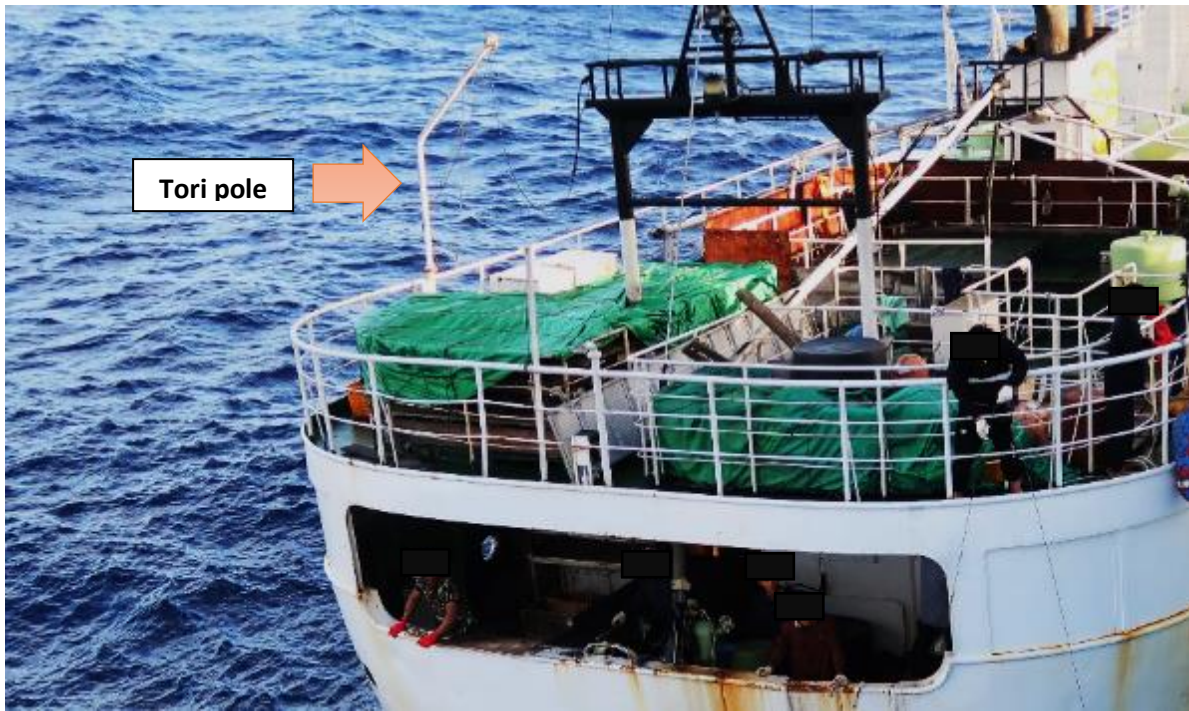
Figure A9. An alternative design for a best practice tori pole.
